Conservation Management Plan

Sydney Harbour Foreshore Authority

103 George Street, The Rocks

Graham Brooks and Associates Pty Ltd
Architects and Heritage Consultants

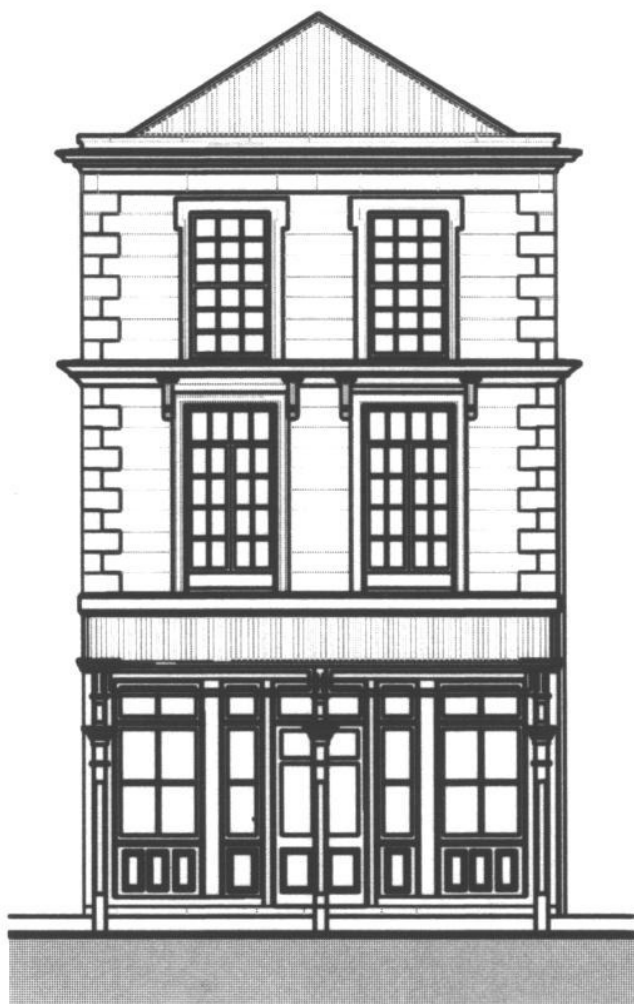
Figure 3

Eastern façade
of 103 George
Street, The
Rocks,
currently The
Ariel Bookshop

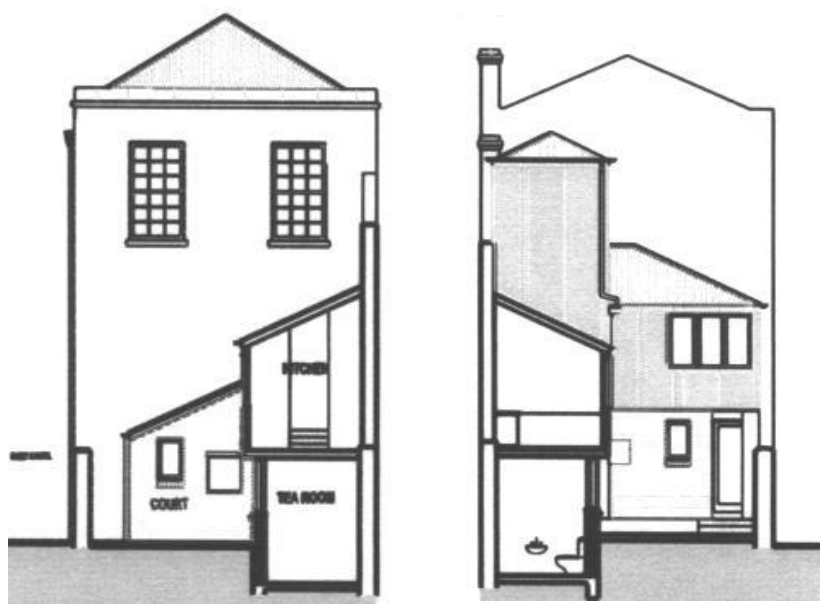
Figure 5
(left) Rear façade
of Front Section

(right) Rear
façade of Rear
Section

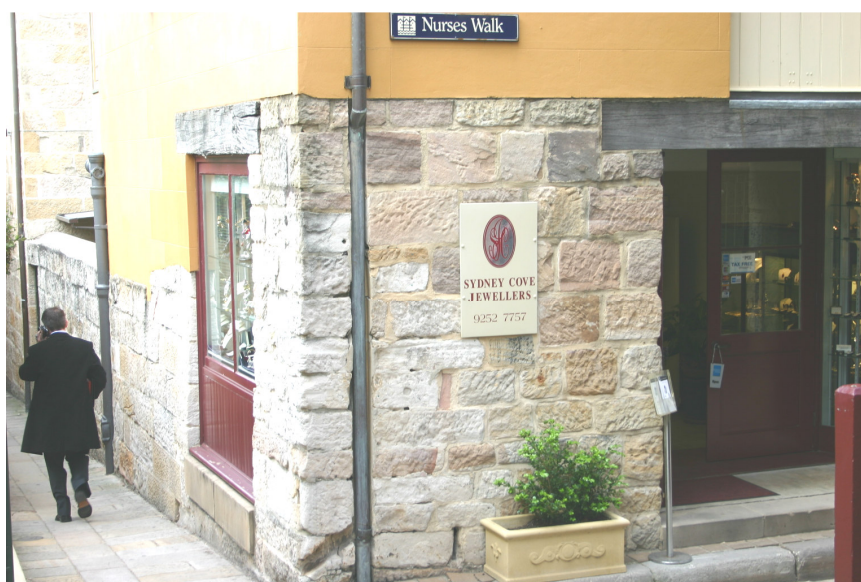
Figure 15

The rear, or third section, showing the differences in height of the ground floor sections of the stone wall (2005)

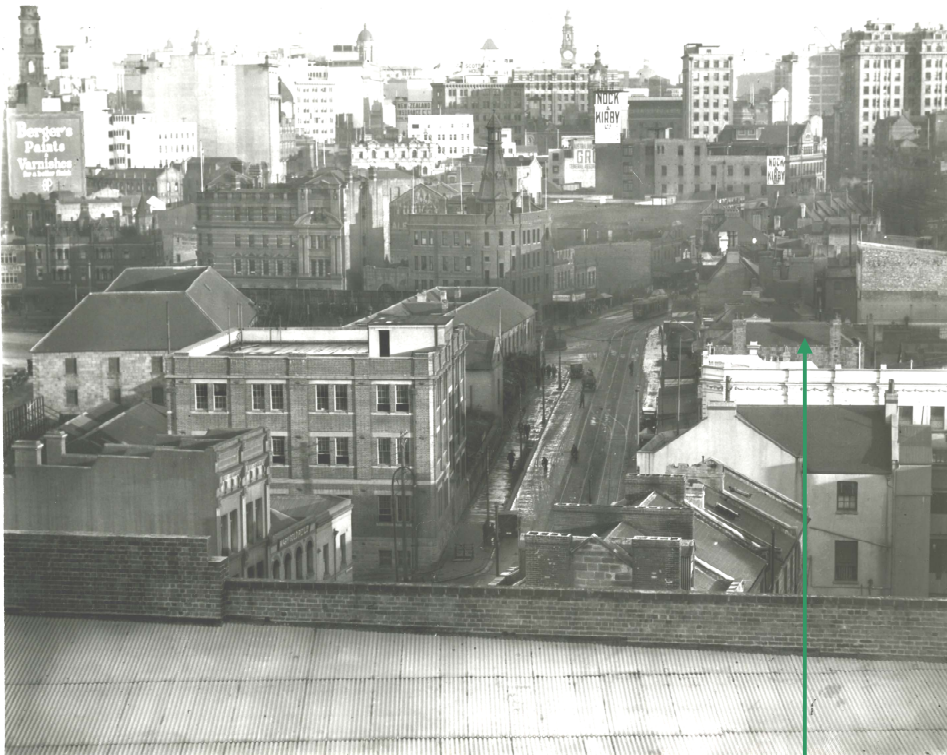
Figure 52

1930 view, looking south, along George Street. The roof of No. 103 still appears to be slate at this time, with the appropriate ridge capping. The Commissariat Stores are still in situ. (Source: SHFA Archives)

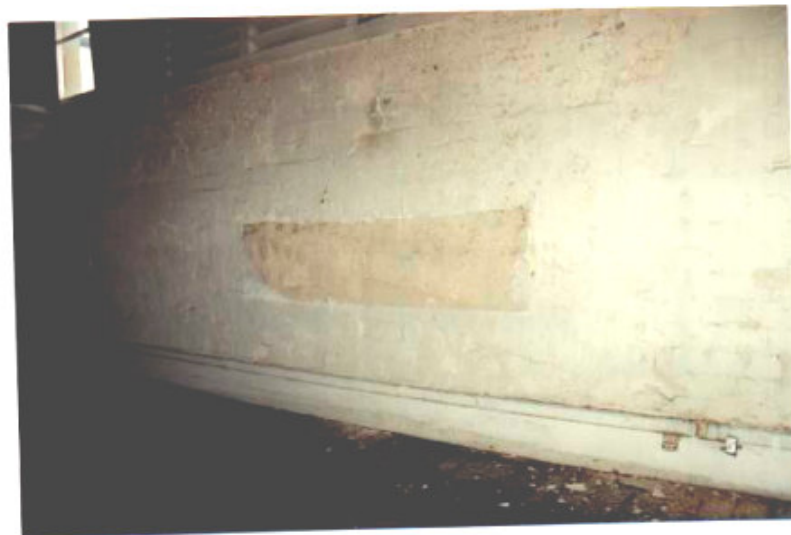
103 1
Stair landing roof plate over Room 1.2a

Closed in camber arch from earlier out building Room 1.4a
